Failure modes of the V2 valves

Outside of drastic situations, fire, water and wreckage, there are two (2) levels of non rectifiable failures and one (1) correctable with the plastic body (V2) valves we are experiencing in the current OPC-M1.

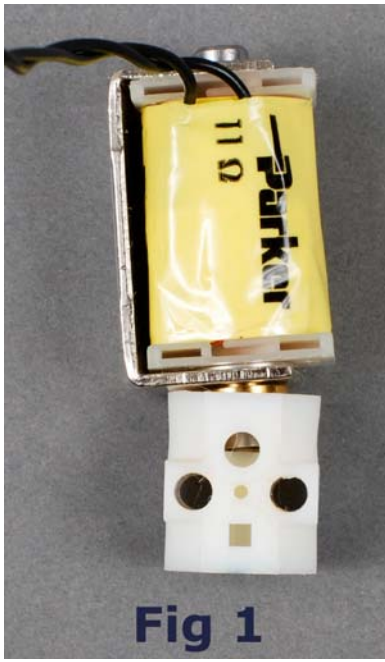
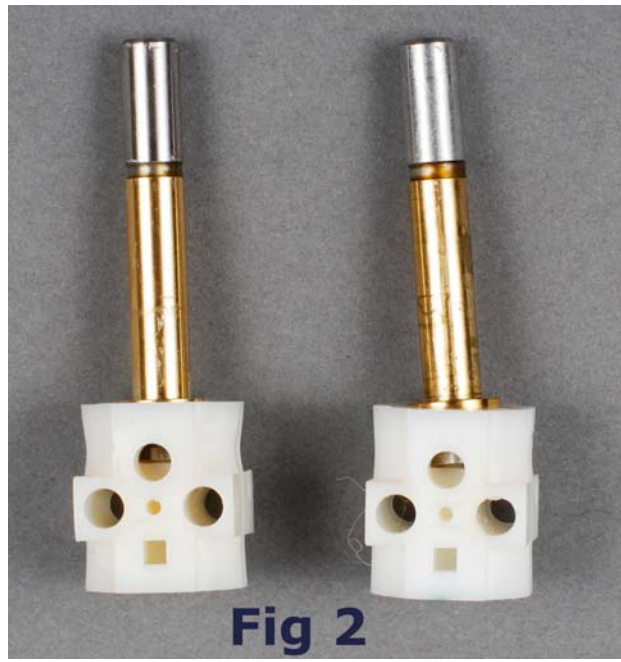
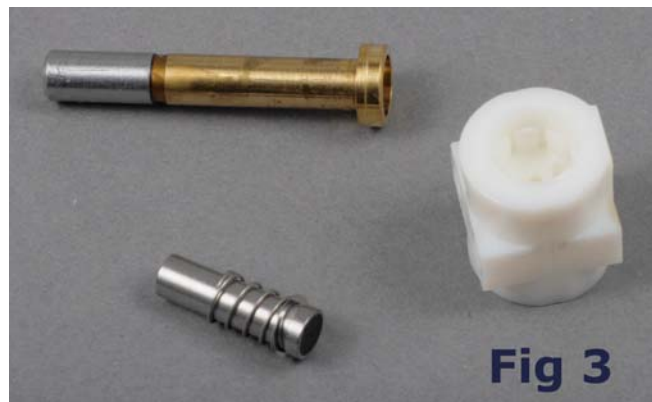
Failure modes of the V2 valves

- 1) Operating the valve beyond its specified pressure range
- 2) Debris on the inlet seat hanging the valve open or causing flow restrictions.
- 3) Plunger stem going out of column in relation to the plastic body (deformation).

This mode of failure is when the valve's plunger stem has been moved 'out-of-column' with respect to the plastic V2 body causing it to leak past the seat, rendering it unusable. This mode of failure is usually from shock exposure during field use. However, we have seen this problem with some new V2 valves directly from stock right from the vendor. This mode of failure is unique to the V2 where the plunger stem is not properly aligned with the body, but otherwise deemed undamaged. Additionally, we are usually unable to detect this visually, rather it usually shows up on our leak test fixture. There is no known method to fix V2 valves with 'out-of-column' plunger-stems. Rather we label them as unusable and store them for future disposition because of the inability to service them. See figures below. With the over pressure operating mode, even the slightest misalignment from modest impacts cause a V2 leak failure. The OPC-M1 mounts the V2 valve to the manifold assy. by the plastic body. This causes a side mass moment that can dislodge the coil & plunger assy. from the body with modest impacts. A bracket (not shown) was added to mitigate V2 valve deformations from shocks and drops, but with modest success.

Current manufacturing processes of the V2 valve renders this failure issue in a much more way from our original versions of the V2 valve used for qualification. Parker Pneutronics has been made well aware of these issues and now states to us that the V2 valve is NOT suitable for use in mobile applications.

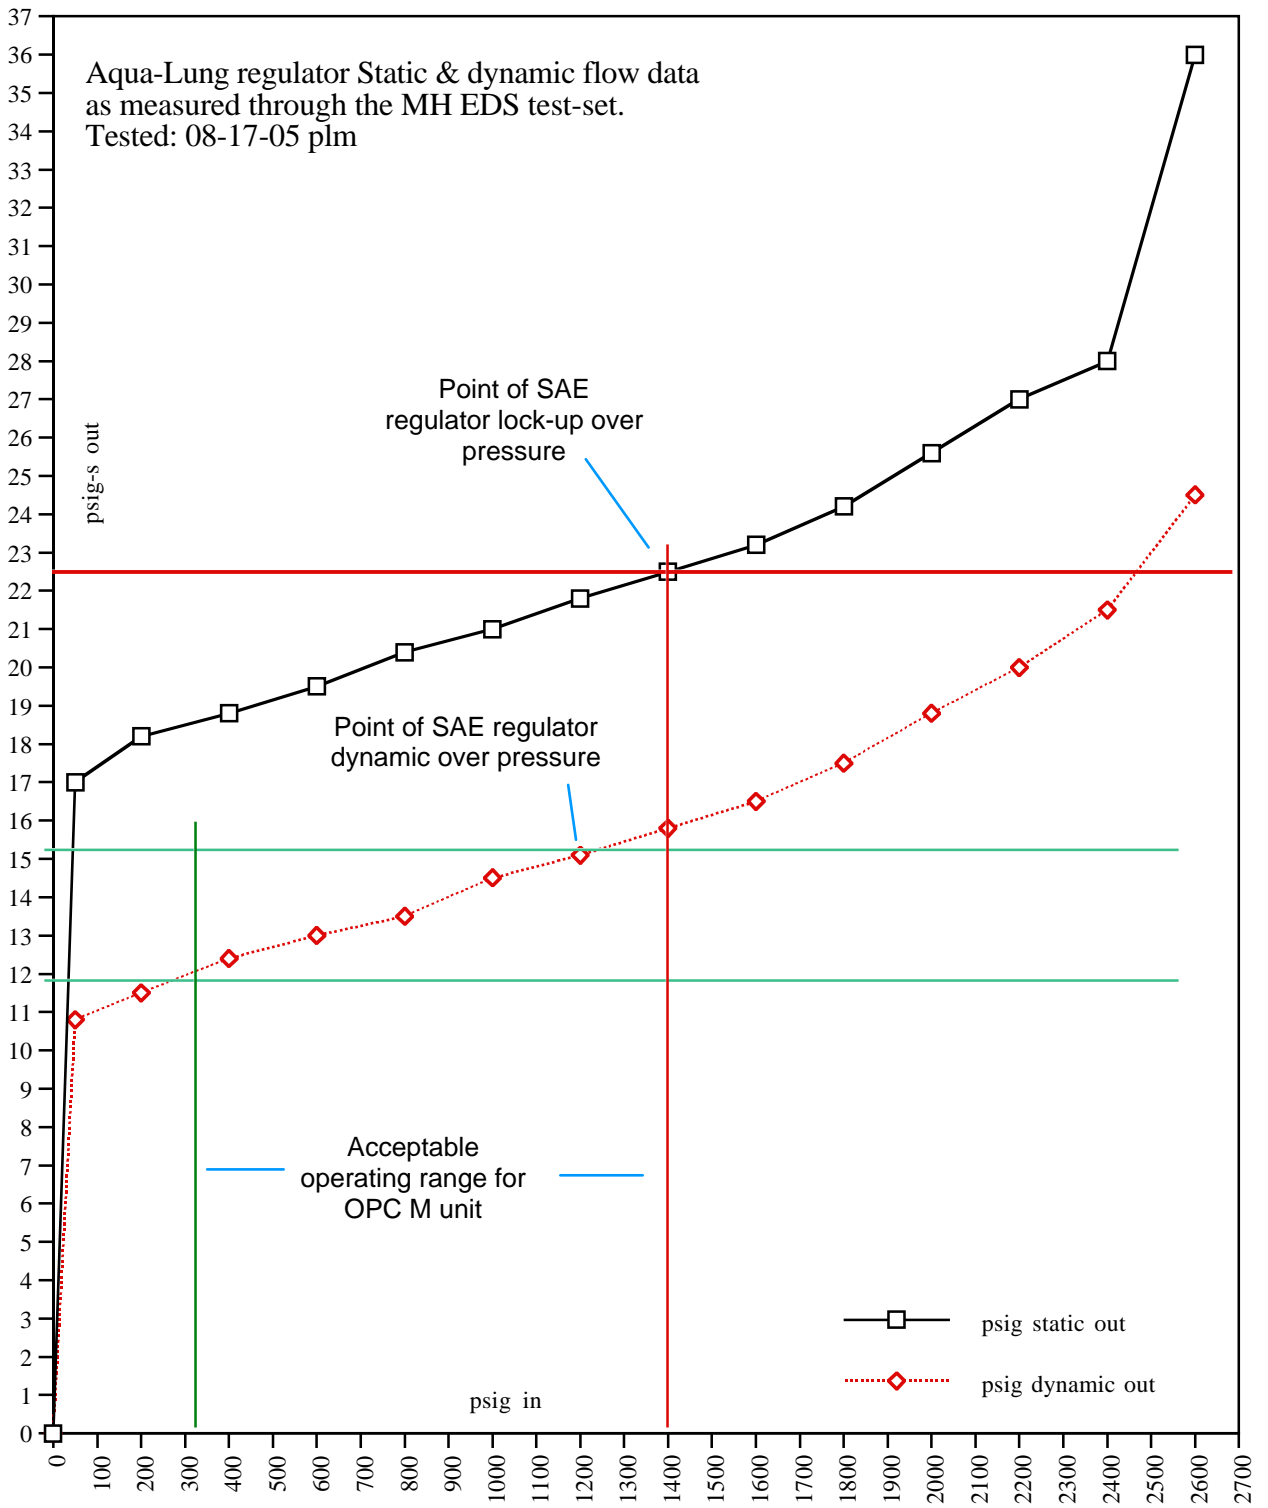
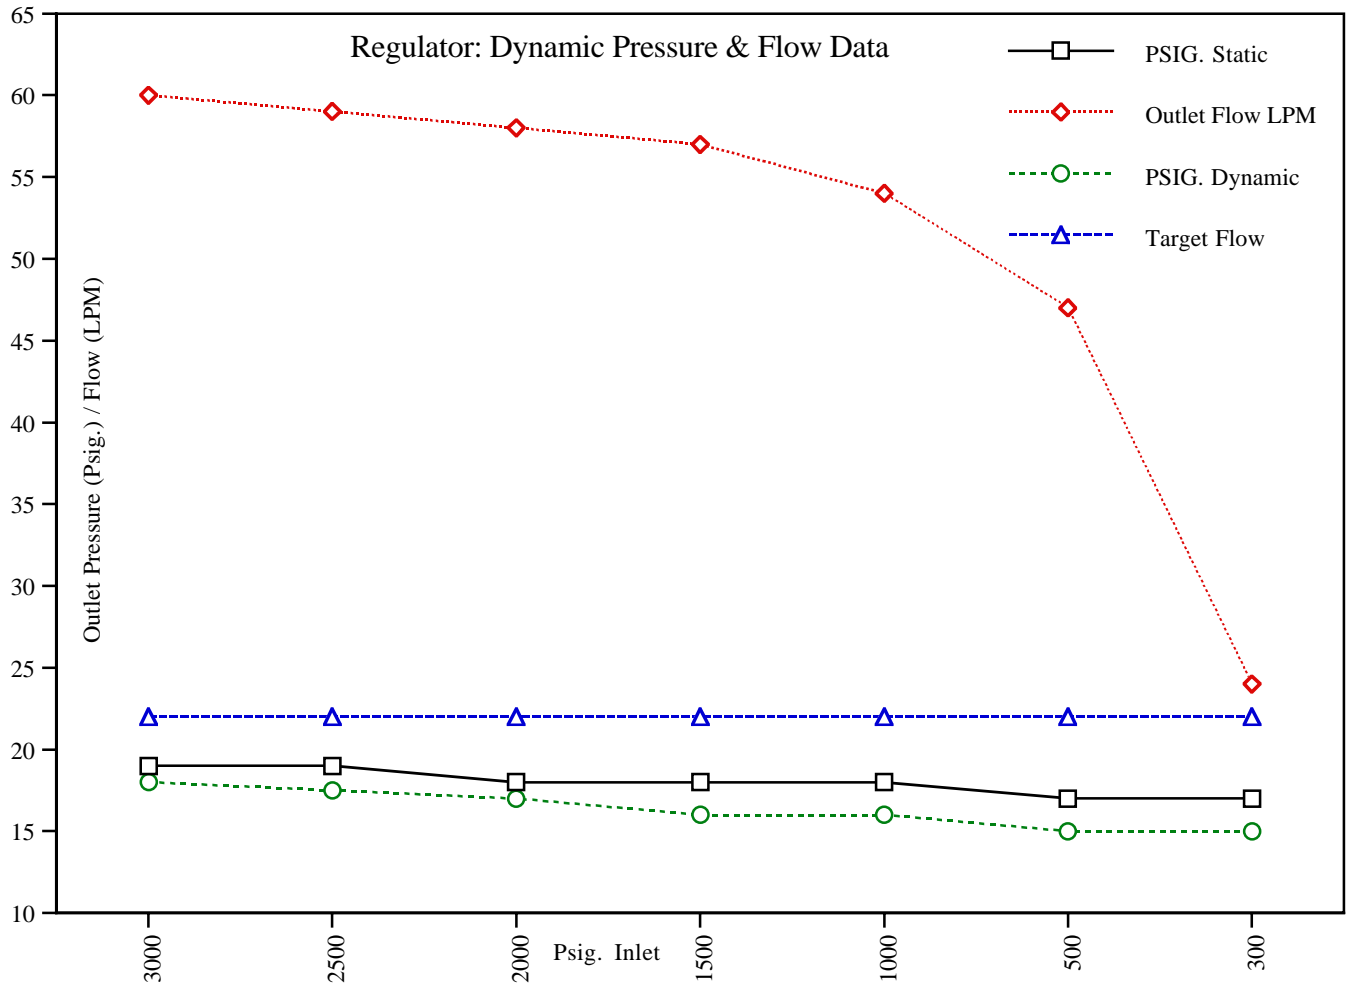
Aqua-Lung regulator Static & dynamic flow data
as measured through the MH EDS test-set.
Tested: 08-17-05 plm

Our regulators virtually have a flat outlet pressure regulation curve for both lock-up (static) and flowing (dynamic) with inlet pressures from 300 to 3,000 psig. Instantaneous, well dampened, oscillation free, flows through a controlled pneumatic resistance are measured at 55 to 60 liters/minute from inlet pressures of 1,000 to 3,000 psig. Target flows are ~25 liters/minute.

EDS units only need to have the regulator to Instantaneously deliver ~10 liters/minute to complement the needed amount of oxygen for pressure altitudes up to 18,000 ft.

Because the modified* version of the SEA-MK-2 regulator used with the OPC-M1 has a lock-up to flow pressure ratio that produces pressure beyond the V2s specification margin and the OPC operating schedule, we are pre testing valves not to have any appreciable leakage at a static pressure of 40 psig. for use in each OPC-M1. See attached page 'Auqa-Lung regulator static & dynamic flow/pressure data'.

The SAE MK-2 has an inlet seat orifice diameter of ~ 0.95" where a high flow-rate at higher pressures are needed for SCBA/SCUBA application. However, in the OPC M units the SAE MK2 regulator body should be fabricated with an inlet orifice diameter of no more than 0.029" and complimented with a proper piston spring so that the lock-up and dynamic flow pressures will not violate the inlet pressure limits of the valve and the delivery schedule of the OPC unit. See next sheets.

It should be expected that the SAE-MK2 regulator could come close to this performance with the noted amendments
